NOLAN CREEK CED RETROFIT

FEBRUARY 4, 2005

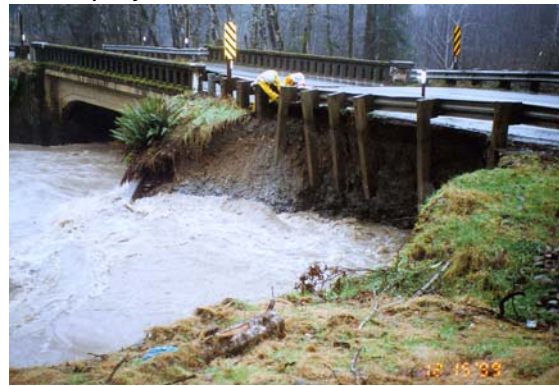
Figure. 1 Nolan Creek CED at high flow prior to construction of the new bridge.

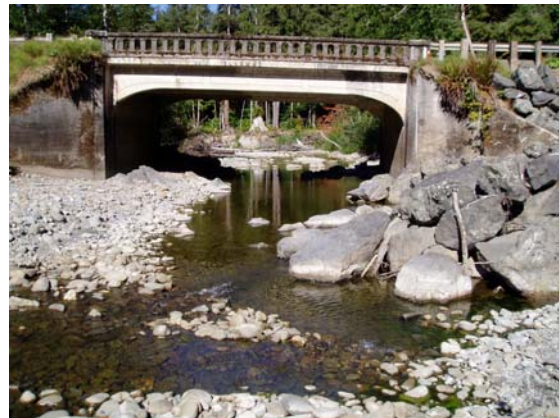
Figure 2. Nolan Creek CED at low flow prior to construction of the new bridge.

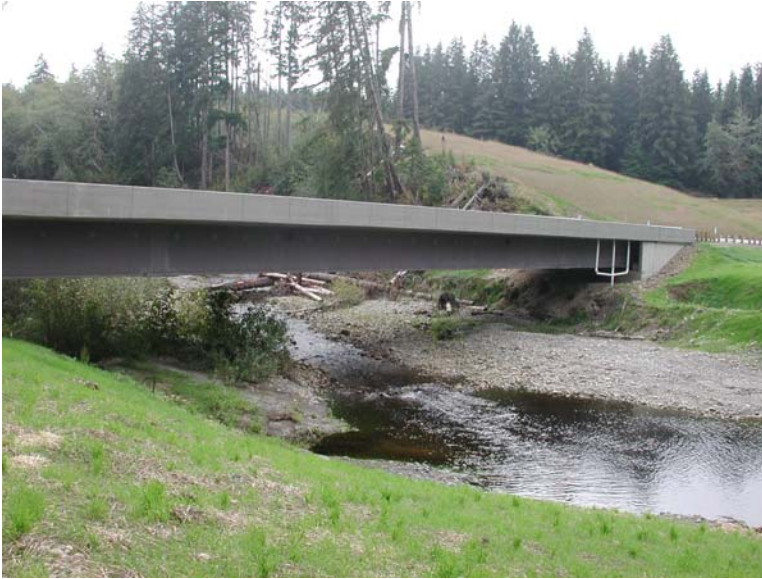
Figure 3. Nolan Creek CED retrofit after to construction of the new bridge.

The new bridge was constructed approximately 65 feet upstream of the existing bridge. The roadway both north and south of the previous bridge was

realigned to the east. The new bridge is a clear span bridge, which does not have any piers or abutments within the ordinary high water mark of Nolan Creek. The riparian area and old roadway were revegetated. As additional mitigation measures, three logjams were constructed in Nolan Creek. The wood source consisted of the trees that were removed at a result of the project.

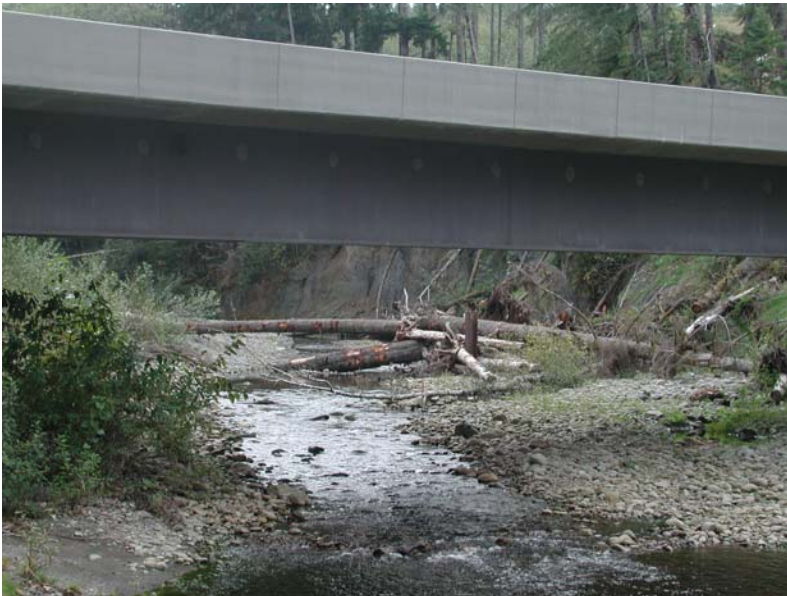
Figure 4. Nolan Creek CED retrofit after to construction of the new bridge.
